Non Destructive testing of poles

Developments in Mod-Shock-InSafe™ in evaluation of Transmission Poles

**Presented by David Tongue to the ESSA Poles
Committee
Adelaide
November 2003**

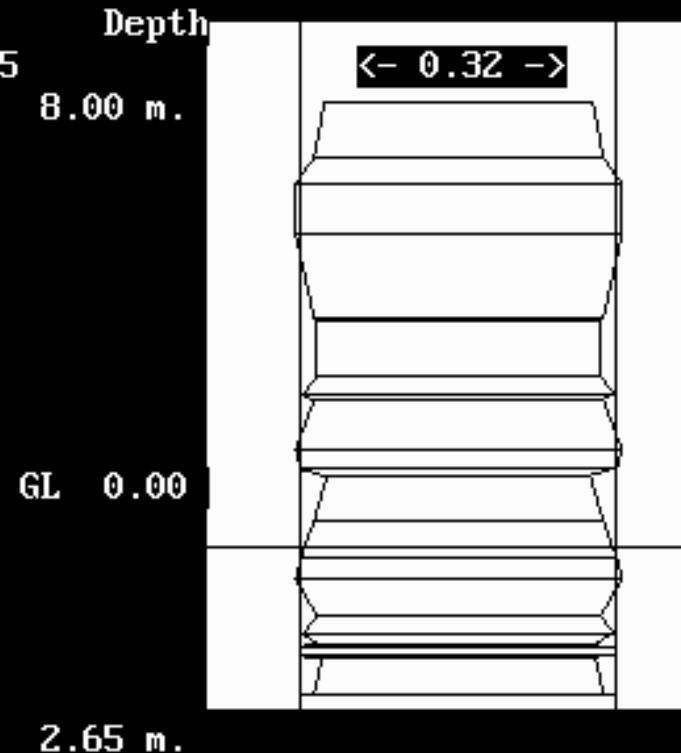
POLE 414213 TEST NUMBER R02 MODEL
MIN Dia 27 CAP 6
CAPACITY 18 KN. STIFF 7.455915E+07 2.73E+05
Depth
Depth Dia Corr Rate Cor% true% Cap 8.00 m.
 6.6 0.385 1 98.2 28
 5.7 0.392 High 1 100.0 32
 4.2 0.300 Low 3 76.5 76.5 44
 4.1 0.281 Low 3 71.6 71.6 44
 3.1 0.288 Low 3 73.4 73.4 58
 2.8 0.346 1 88.1 66
 2.7 0.296 Low 3 75.6 75.6 68
 1.8 0.385 1 98.2 103
 1.4 0.356 1 90.7 ---
 1.3 0.234 Low 3 59.7 59.7 ---
 0.5 0.297 Low 3 75.6 75.6 ---
 -0.2 0.360 1 91.8 ---
 -0.6 0.392 High 1 100.0 ---
 -1.2 0.281 Low 3 71.6 71.6 ---
 -1.5 0.346 1 88.1 ---
 -1.7 0.261 Low 3 66.6 66.6 ---
 -1.8 0.356 1 90.7 ---
Ave dia .3194968 1 91.8 ---
C = RETRY X = Return W= Write

Screen dump from InSafe™

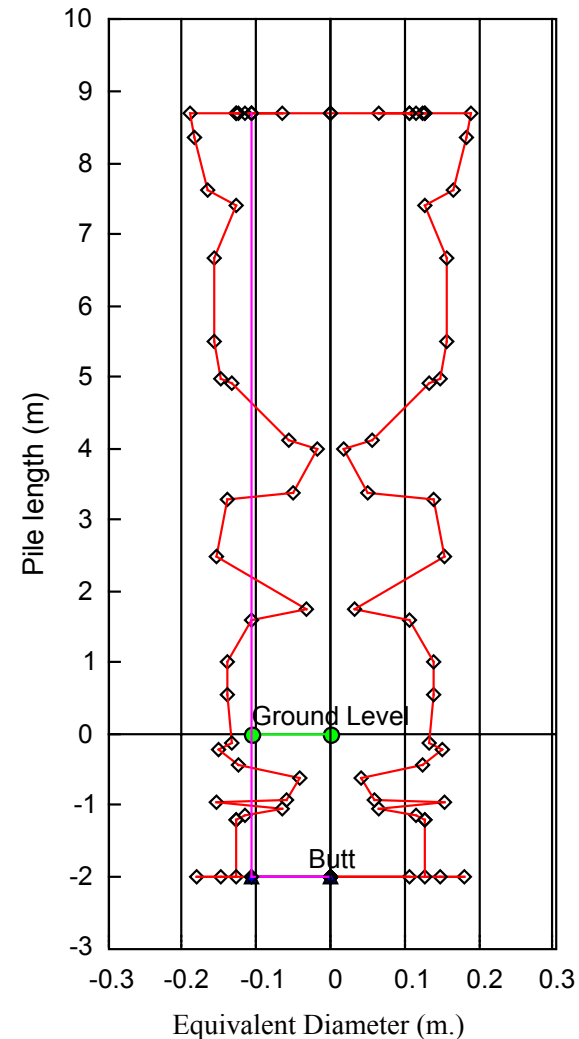
Pole 255

- Pole classed as serviceable
- Model shows loss at GL -400mm
- Also at GL + 4.0m
- Pole was removed for inspection

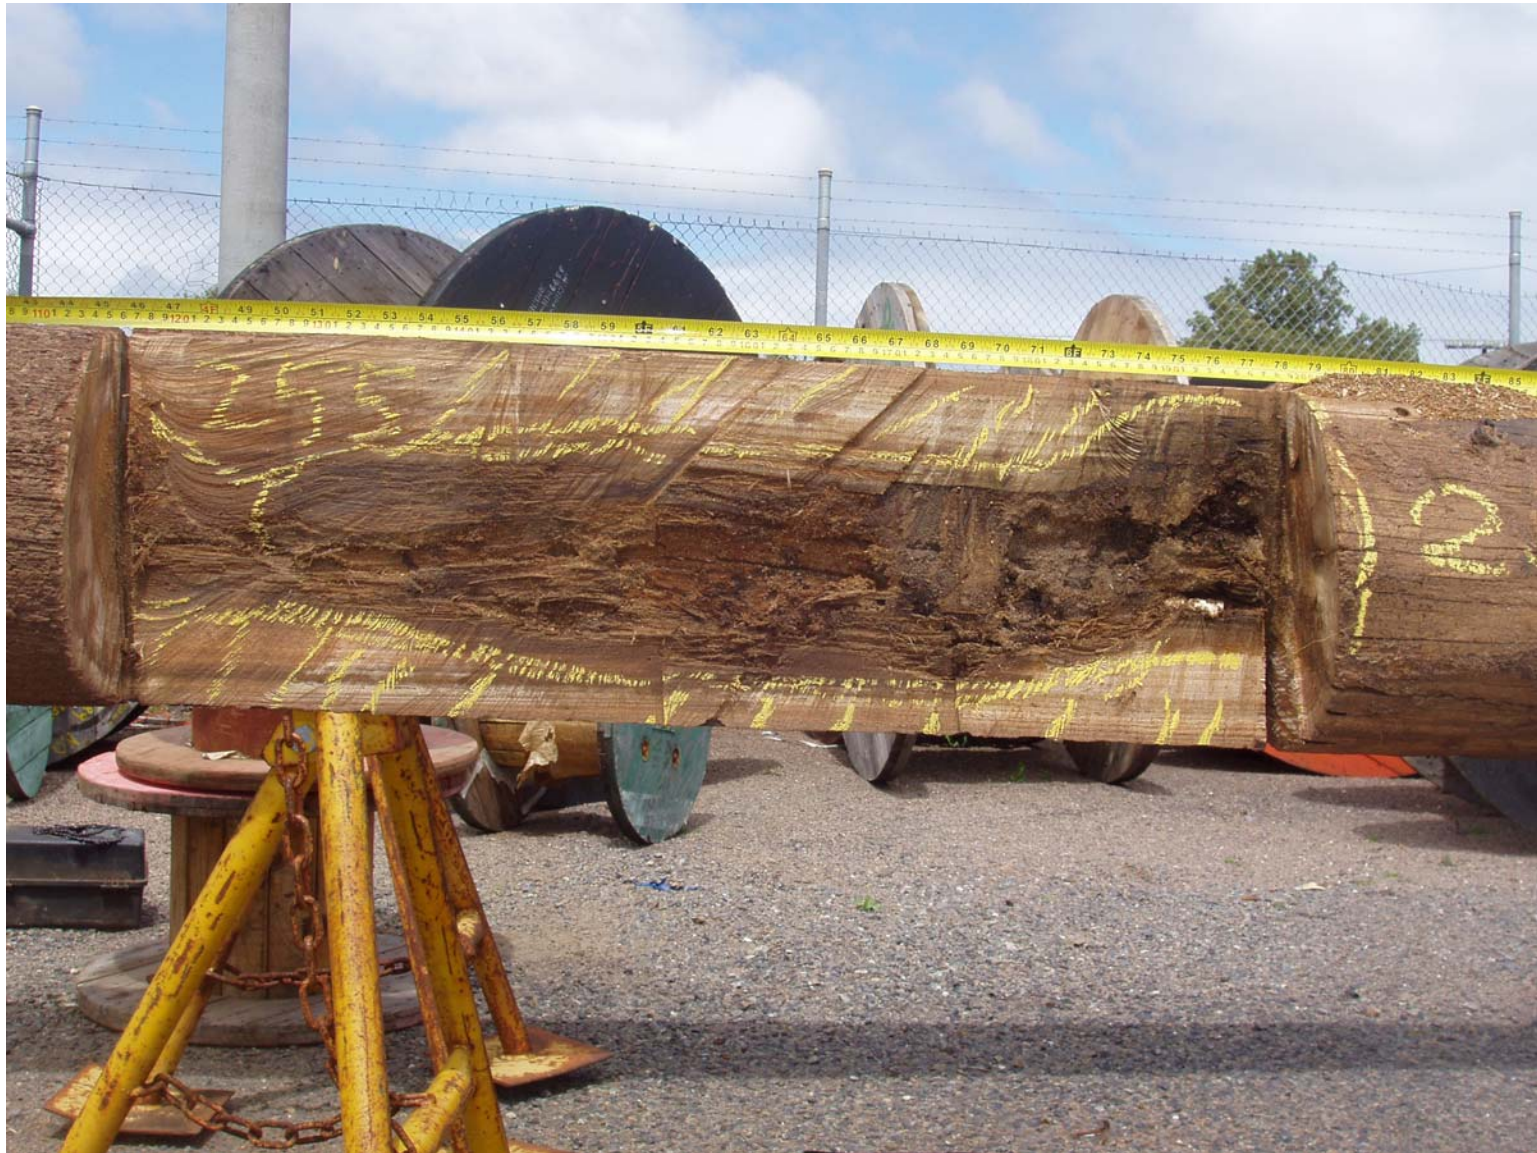
Pole 255

Pole
Sectioned
At Ground
level
Good wood
shaded yellow

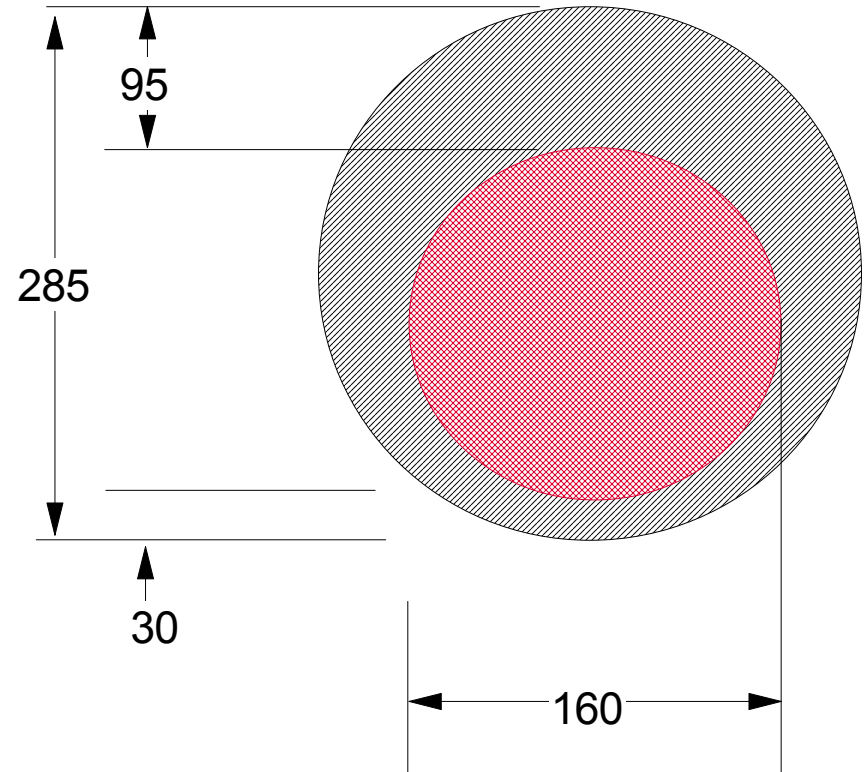
Pole 255

- A measured cross section is given
- Approximately 160mm pipe is found
- Filled with wet rot wood

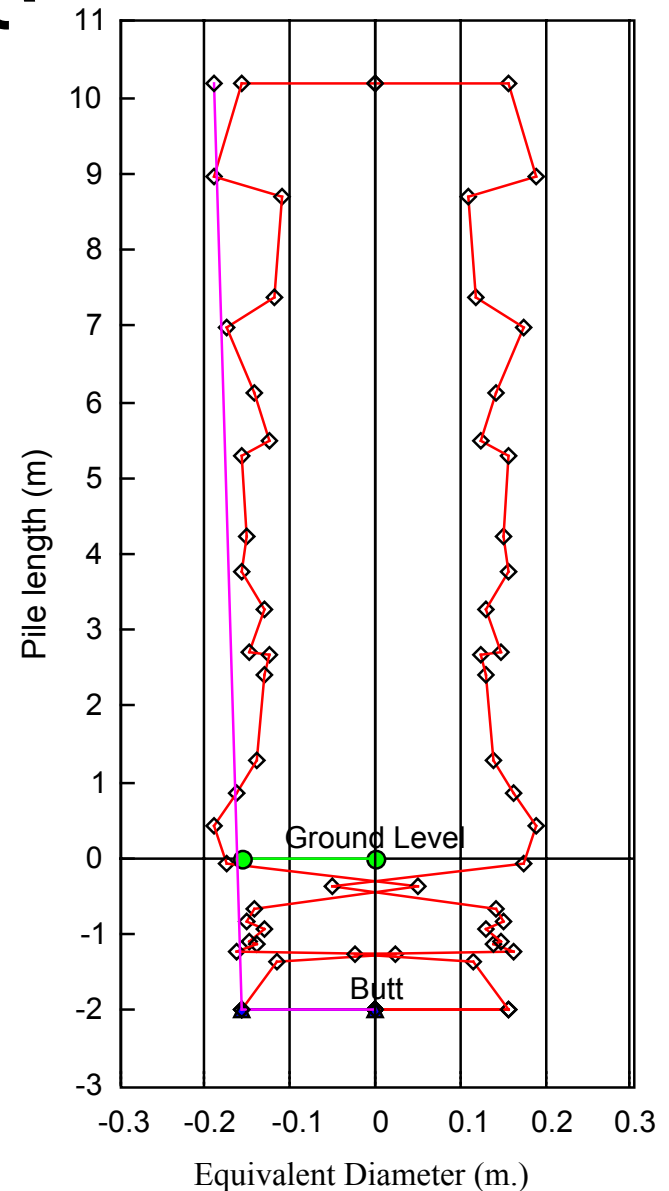
Pole 43

- Pole classed as limited life with 40mm wall
- Inspected this year
- Model from test shown
- Major loss shown below ground line

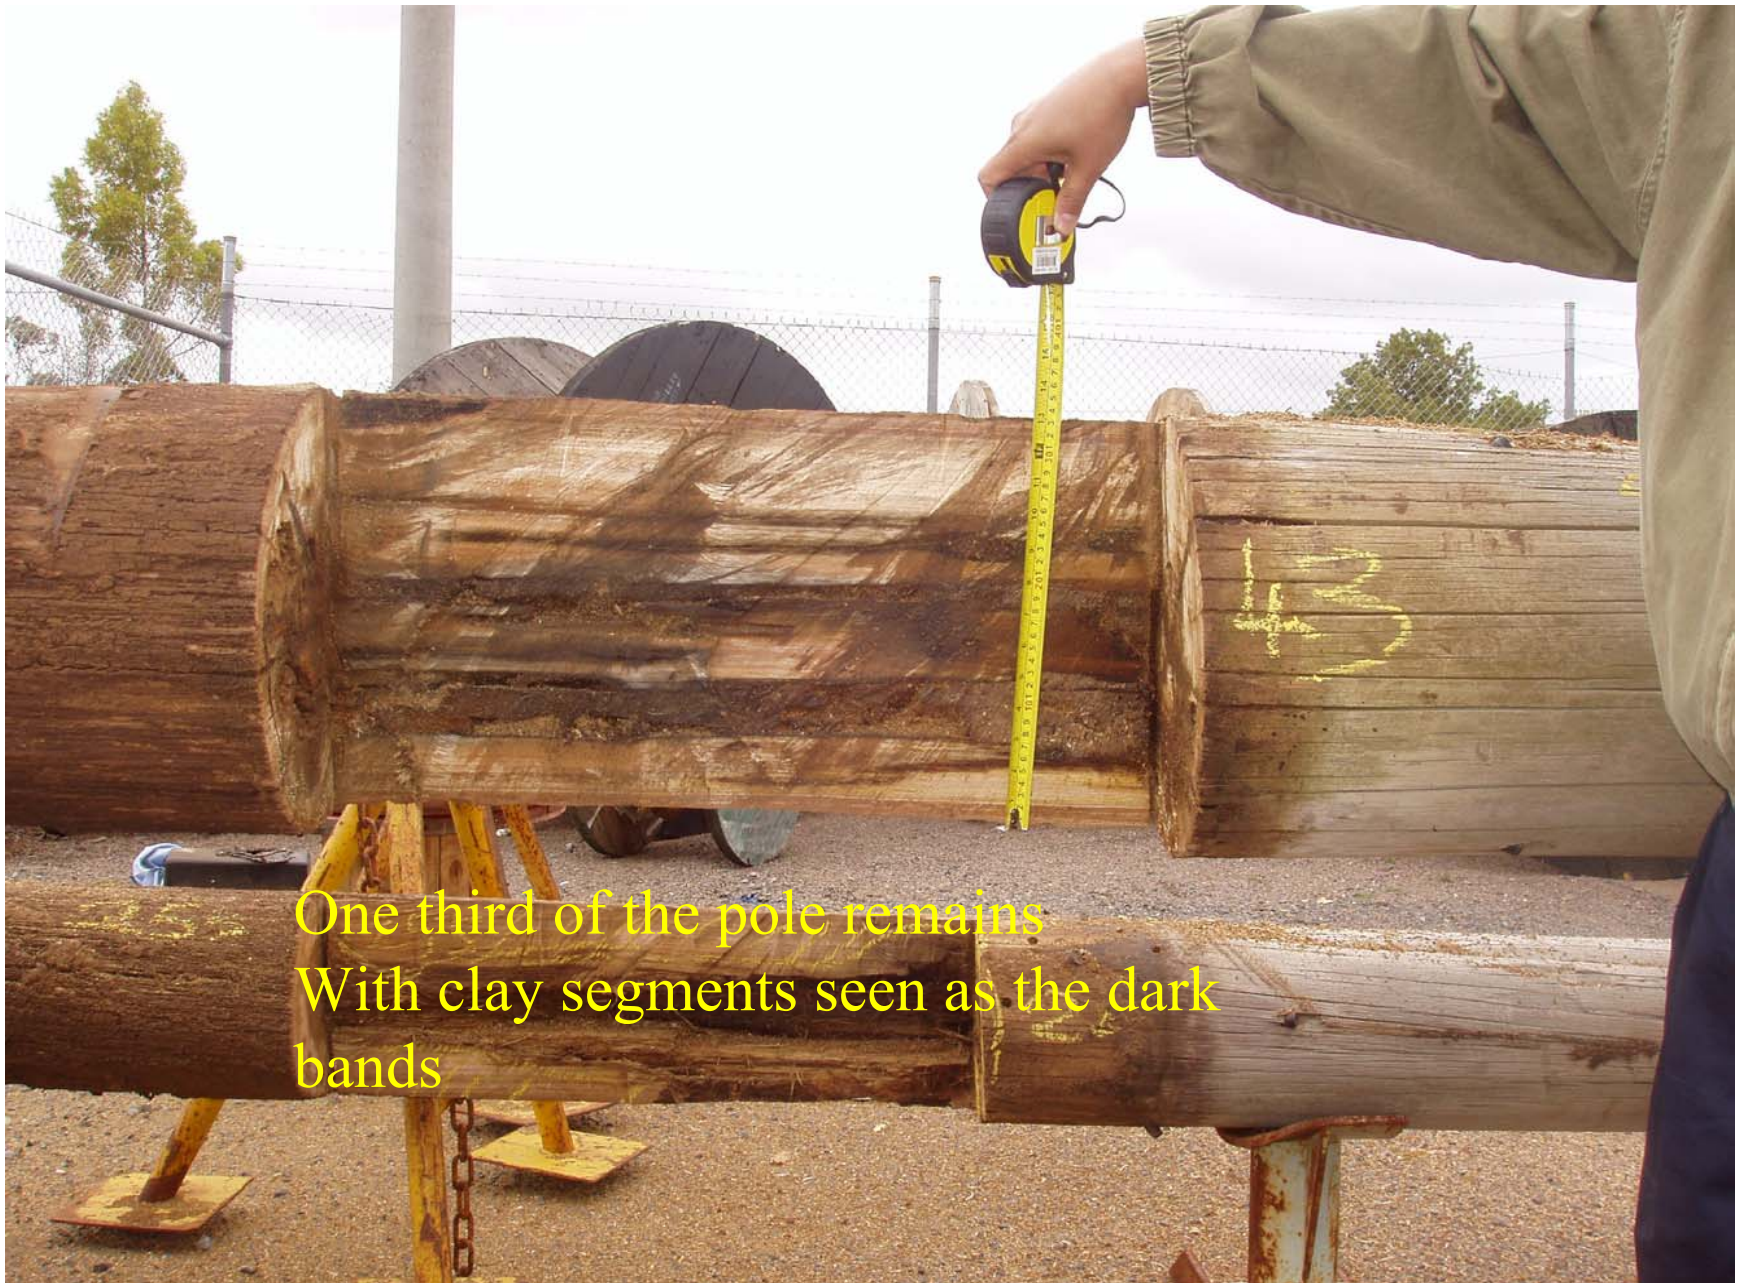
Pole 43

One third of the pole remains
With clay segments seen as the dark
bands

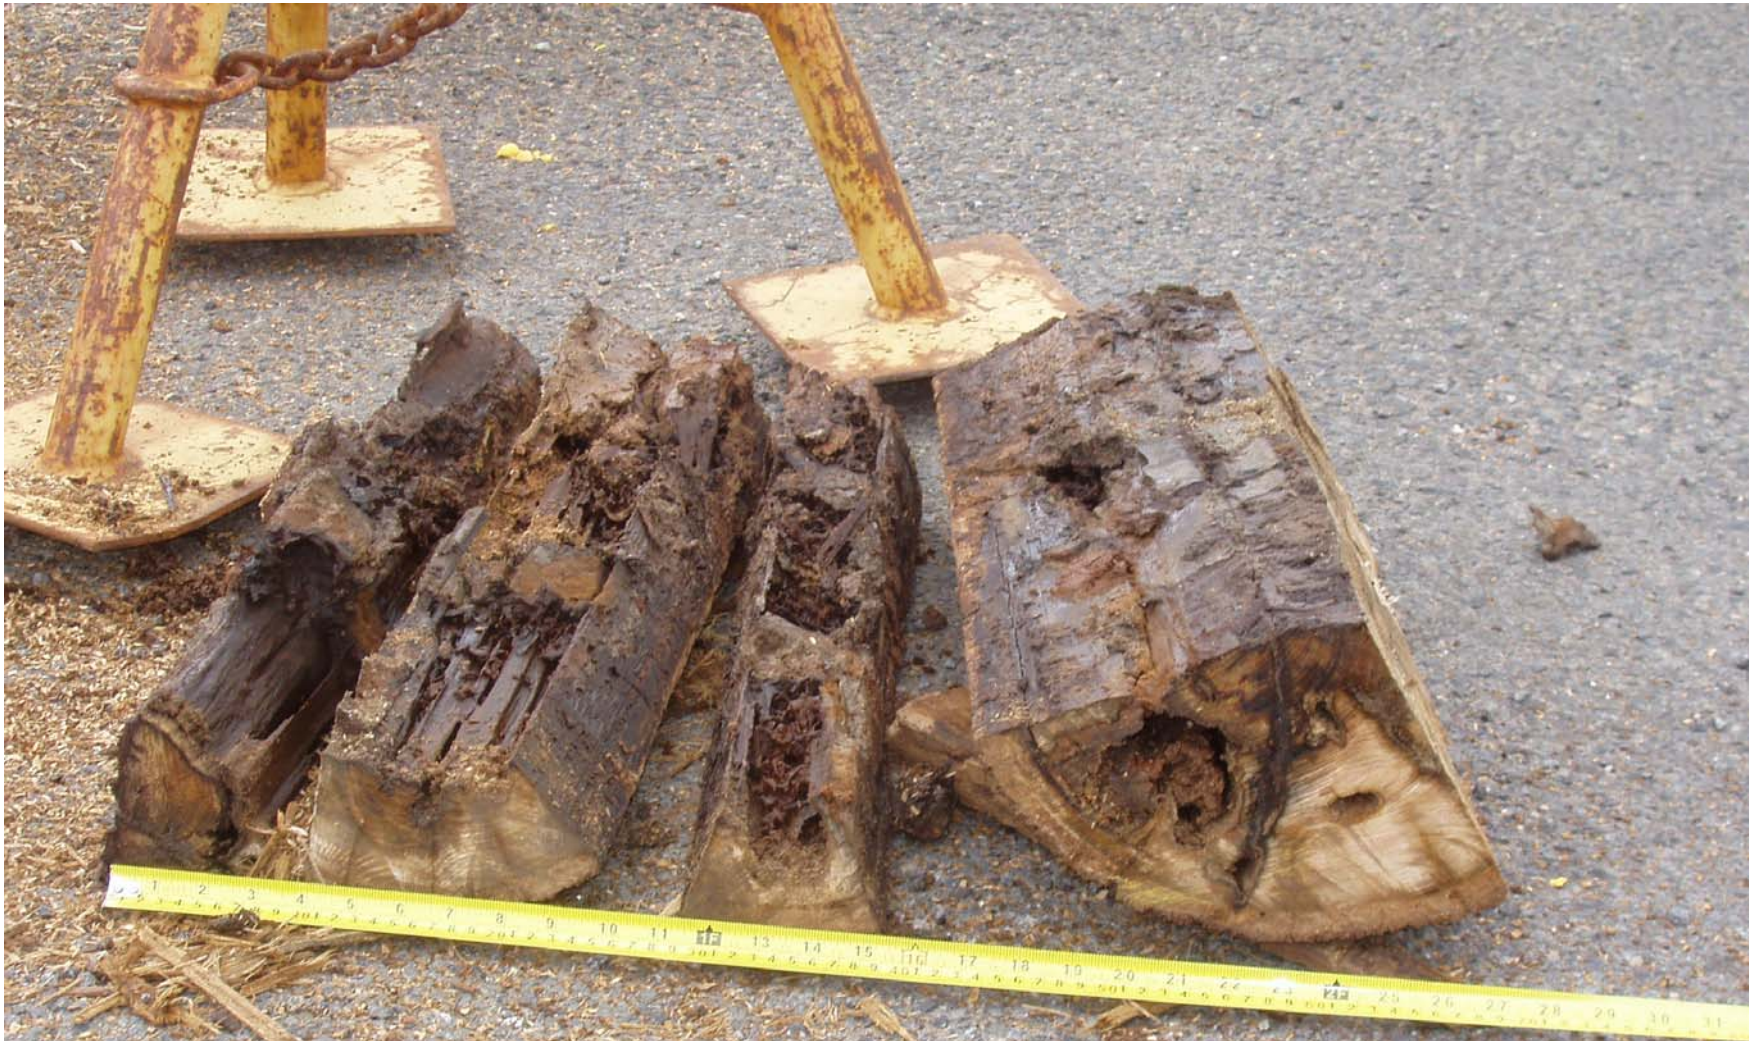
Pole 43

The pole Section split into pieces only the right hand side shows any good wood.

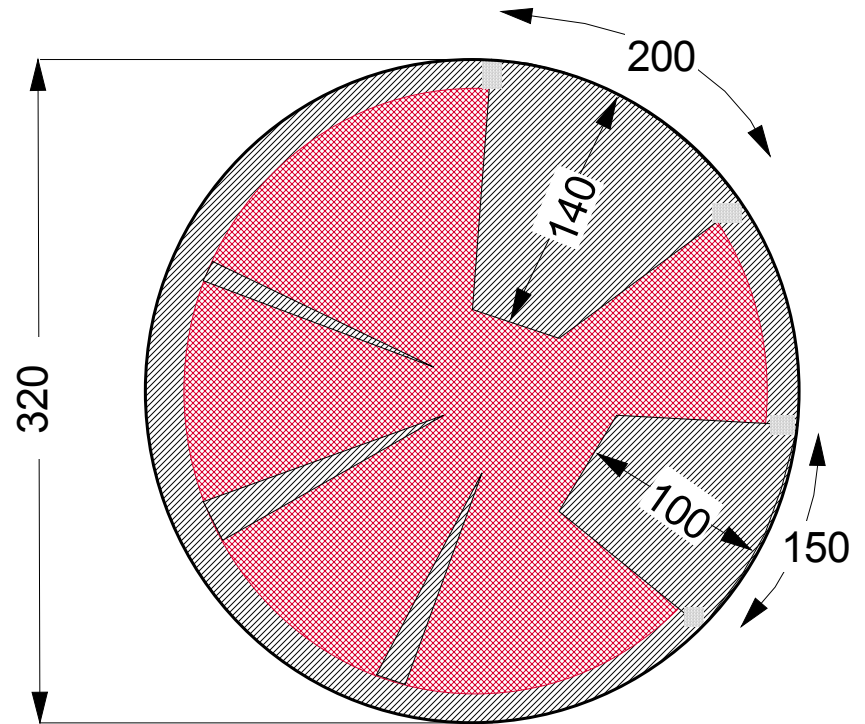
Pole 43

- Cross hatch section
red section is the loss
due to termites

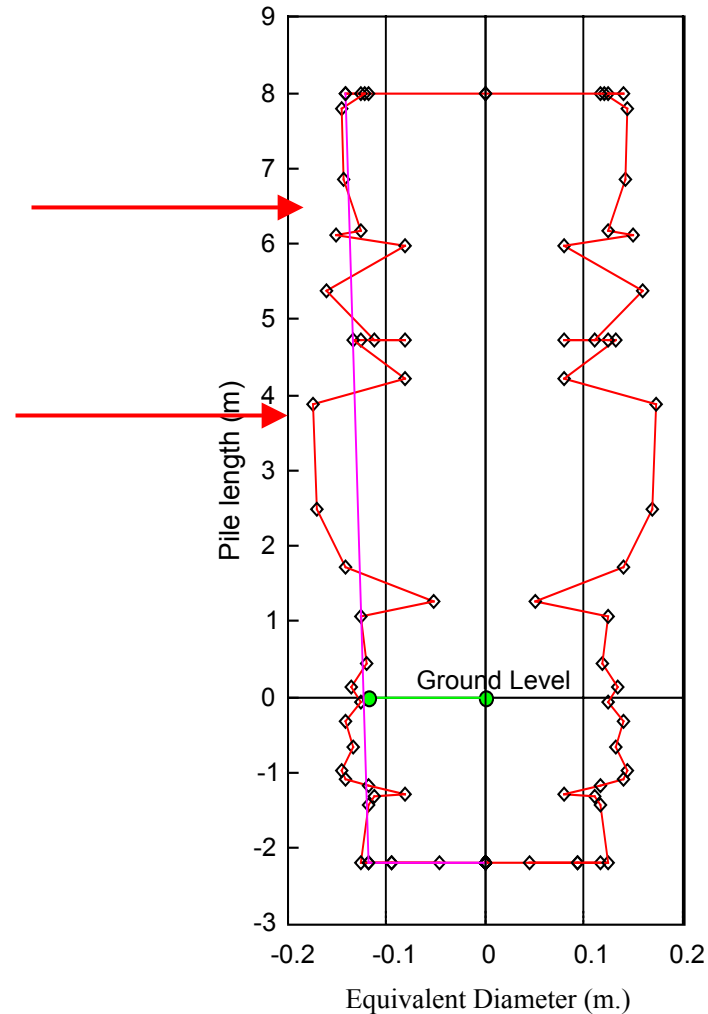
Pole 239 Non-Traditional search area

- The model showed loss of section from GL + 4.0 to GL + 6.2 m also areas 0.1 GL and -0.9 GL.
- After removal and cutting the pole at level +4.0 to +6.2 m, the exposed pole indicated rot and termite.
- At +5.5 metre the wall was measured to be 55 mm.
- At + 4.9 metre the wall thickness was measured 20mm.
- InSafe™ model showed a 17mm wall thickness.

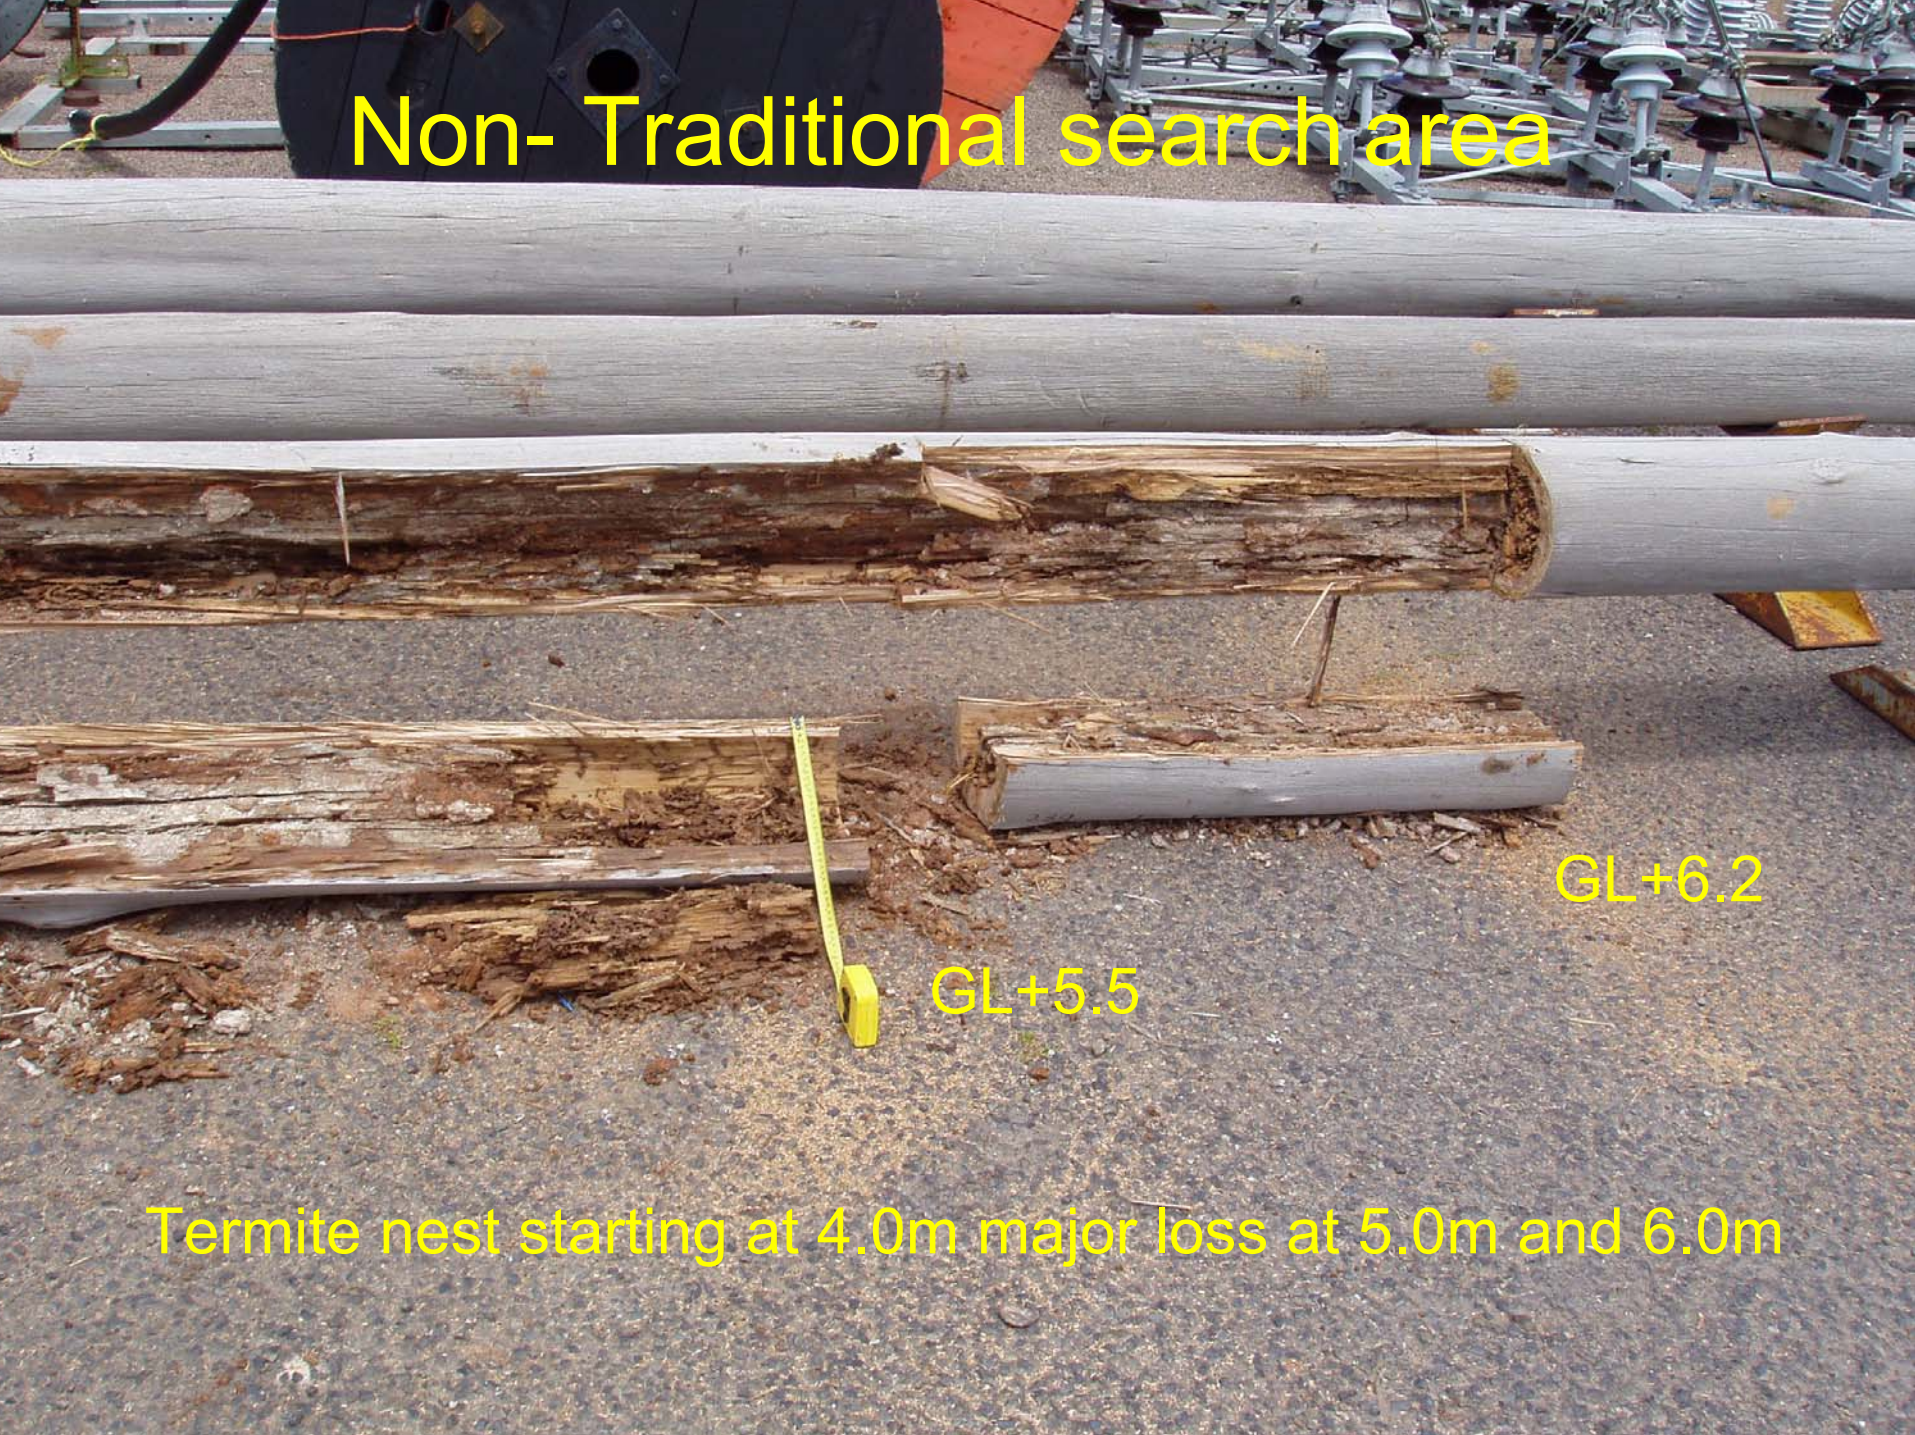
Non- Traditional search area

Termite nest starting at 4.0m major loss at 5.0m and 6.0m
