## ModShock™, Pole Test Version

By J.S.Higgs and D.J.Tongue of Integrity Testing Pty. Ltd.

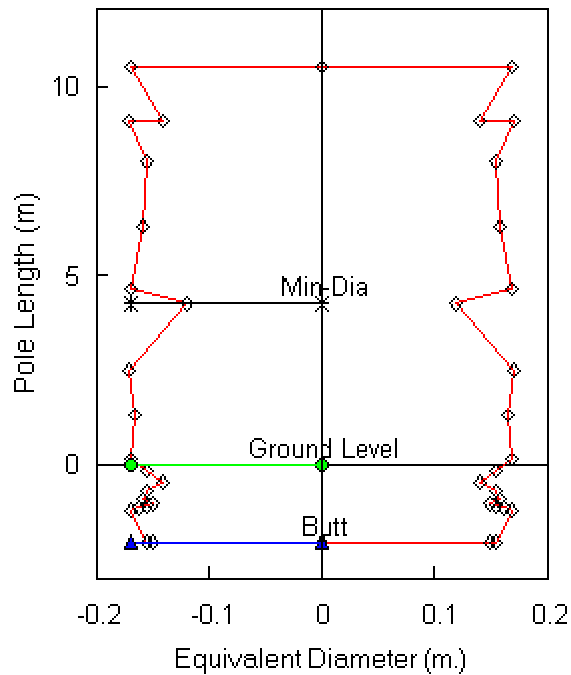
**2D RESULT Fig:1**

The ground line position as well as the total length of the pole can now be measured to within 300mm, that is plus or minus 150mm and has been consistent over a large number of samples. This allows better positioning when trying to determine where the defective areas are on the pole and referenced to the ground line. Though this was a minor aspect of the work with Energy, the measurement of the loss of section was within 10% of the actual loss at any location on the pole.

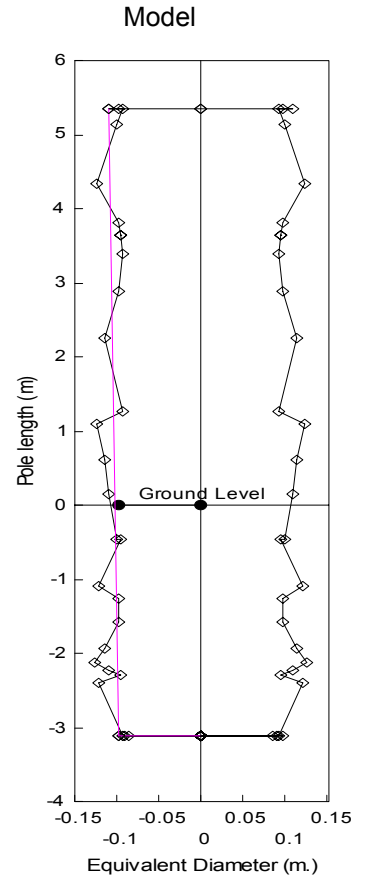
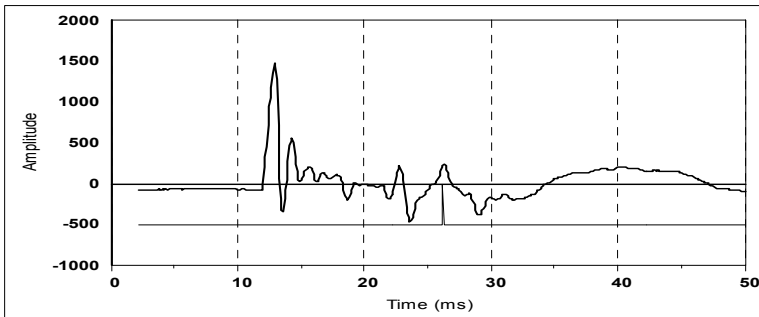
## Example Mod-Shock™ Pole Test results

- Analysis is now complete and for the defect location system a RATING table is seen on the screen, see attached form on the top left hand side of the form. The rating values can be suited for the various client's requirements, but generally any value 3 and above requires further investigations. The depth to the defects are noted in the same table, so it is easy to determine the location to be inspected for further investigation. In addition to the Defect location in the capacity system the Tip Bending Moment is displayed, as well as the Bending Moment at other locations on the pole.

- Also on the form is a 2D model of the pole with the diameter and lengths identified, on the top right hand side of the form.
- At this point the operator can decide whether the pole requires further inspection or not. If the client requires the decision on acceptance or not, to be carried out by a supervisor the information can be dispatched to the office by electronic or other means for decisions to be made by others.

Test No: 9e      Pole No: MP009  
**Pole Capacity**      **9 Kn**      **7 Kn BM**      **59**

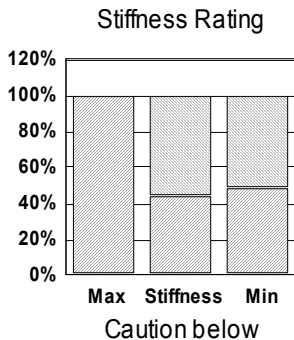
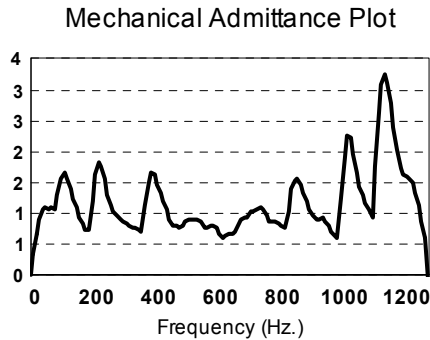
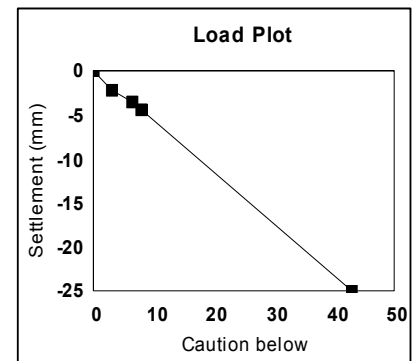
Deflection mm	Load KN.
0.00	0.00
2.06	3.15
3.49	6.65
4.39	8.18
25.00	43.25
