## MOD-SHOCK™ TESTING OF PILES AND POLE STRUCTURES CORRELATIONS

# Integrity Testing Pty Ltd

# Mod-Shock testing of Piles Etc.

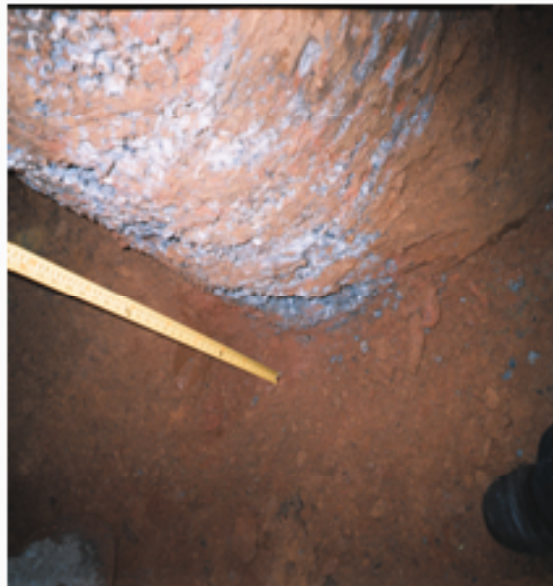
### Pile Testing Result and Photo

A test on a piled foundation to a lattice tower in New Zealand, towers had fallen over in high winds.

- We discovered that a number of the bored piles supporting the towers had not been properly compacted.
- The client dug down on a number of the piles to indicate whether our findings were and the previous slide indicated that this particular pile the concrete had not be compacted properly and under high wind loadings similar piles had failed in the shaft of the piles.

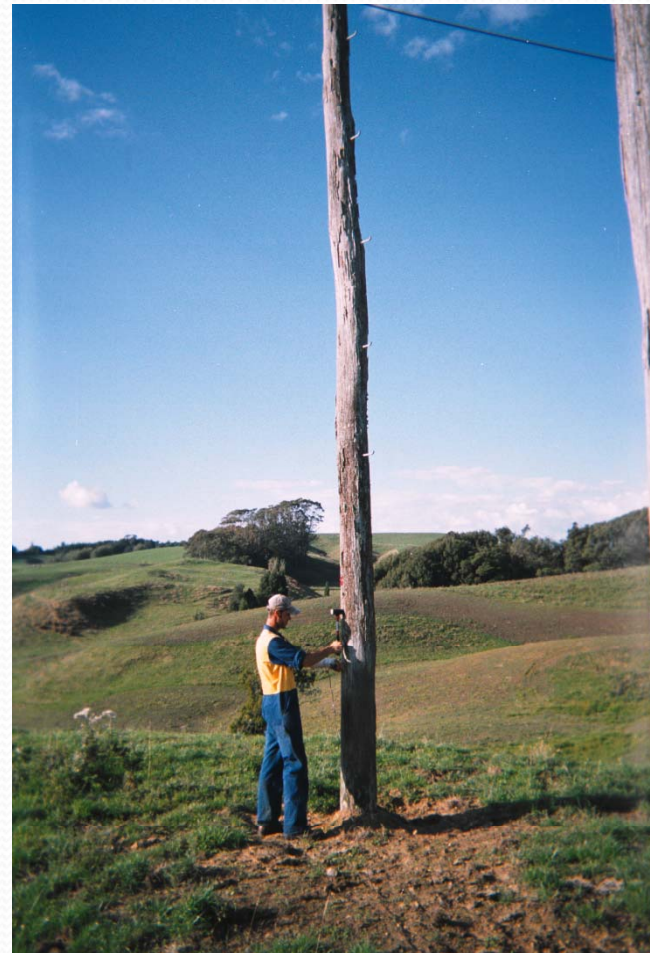
# Pole Testing-Method Example

- Excite Pole by using striking with a suitable hammer.
- Record response in laptop computer and analyse.
- Analysis using established parameters yields results on pole length, buried depth, defects and load capacity
