MOD-SHOCK™ TESTING OF PILES AND POLE STRUCTURES CORRELATIONS

Integrity Testing Pty Ltd

Mod-Shock testing of Piles Etc.

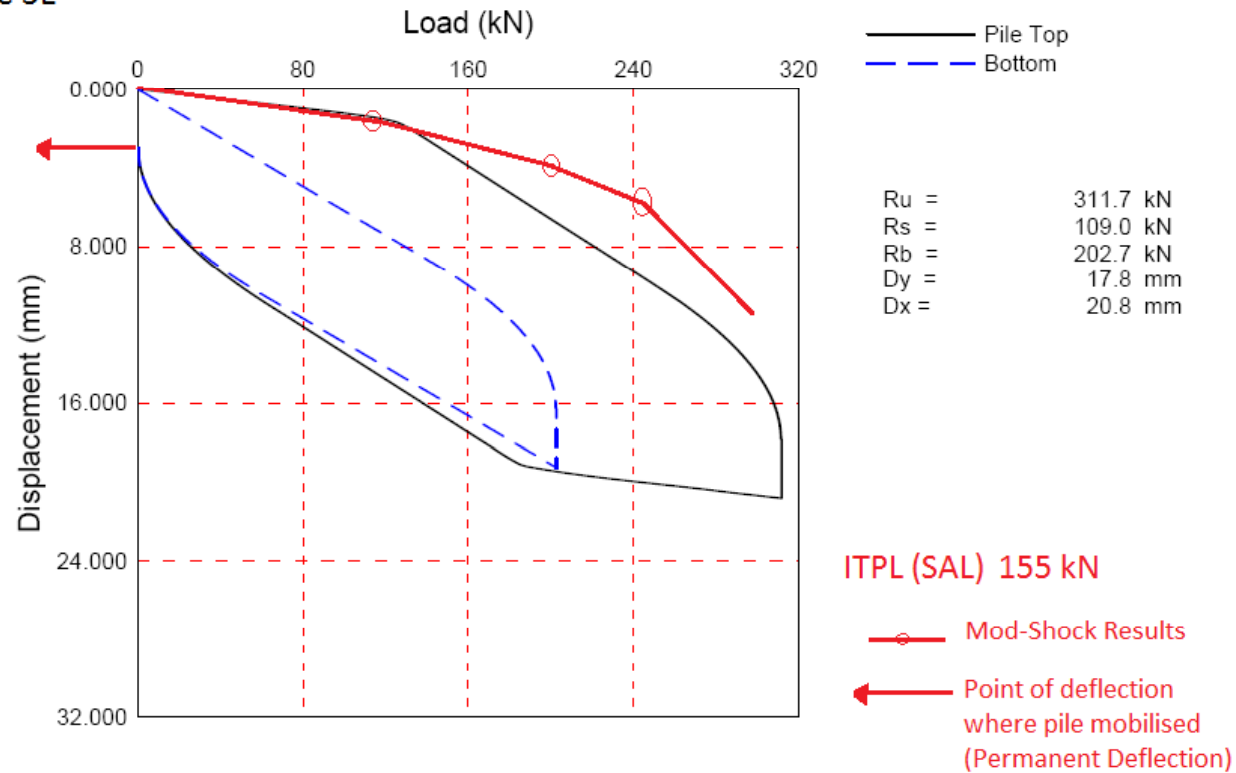
Pile 3E

Result for pile no 3E.

Analysis of results for pile 3E

- PDA results indicated that the pile moved at approximately 4mm deflection and there was a permanent set of minus 4mm.
- The load at this point was 170 Kn
- Our SAL indicated at a 3.0mm deflection a load of 155Kn.
- We consider that we may be slightly conservative, but well safe from permanent deflection.

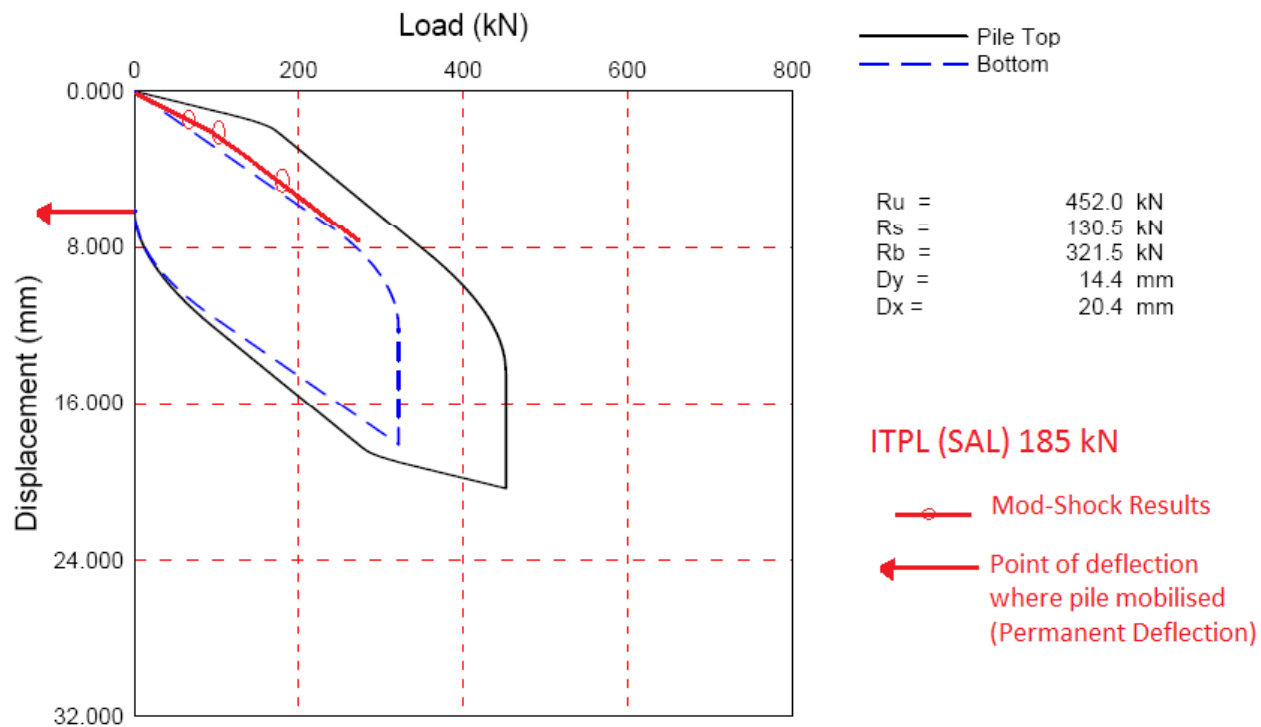
Pile 30E

Results for pile 30E

Analysis of results for pile 30E

- PDA results indicated that the pile moved at approximately 4mm deflection and there was a permanent set of minus 4mm.
- The load at this point was 220kn.
- Our SAL indicated at a 3.0mm deflection a load of 185Kn.
- We consider that these results indicate a virtually similar result and still within the elastic limit of the pile.

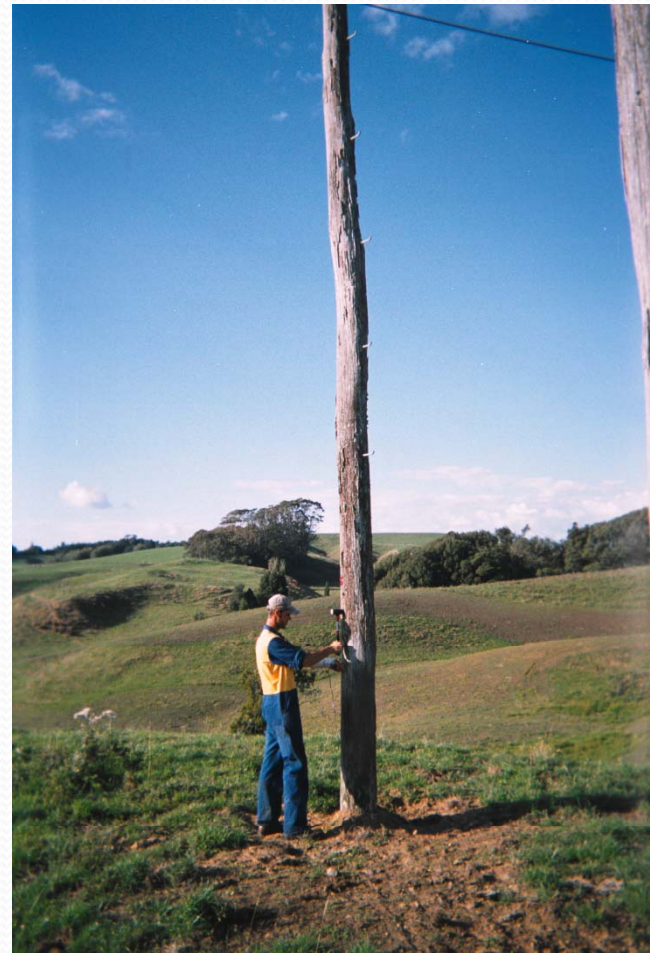
Pole Testing-Method Example

- Excite Pole by using striking with a suitable hammer.
- Record response in laptop computer and analyse.
- Analysis using established parameters yields results on pole length, buried depth, defects and load capacity

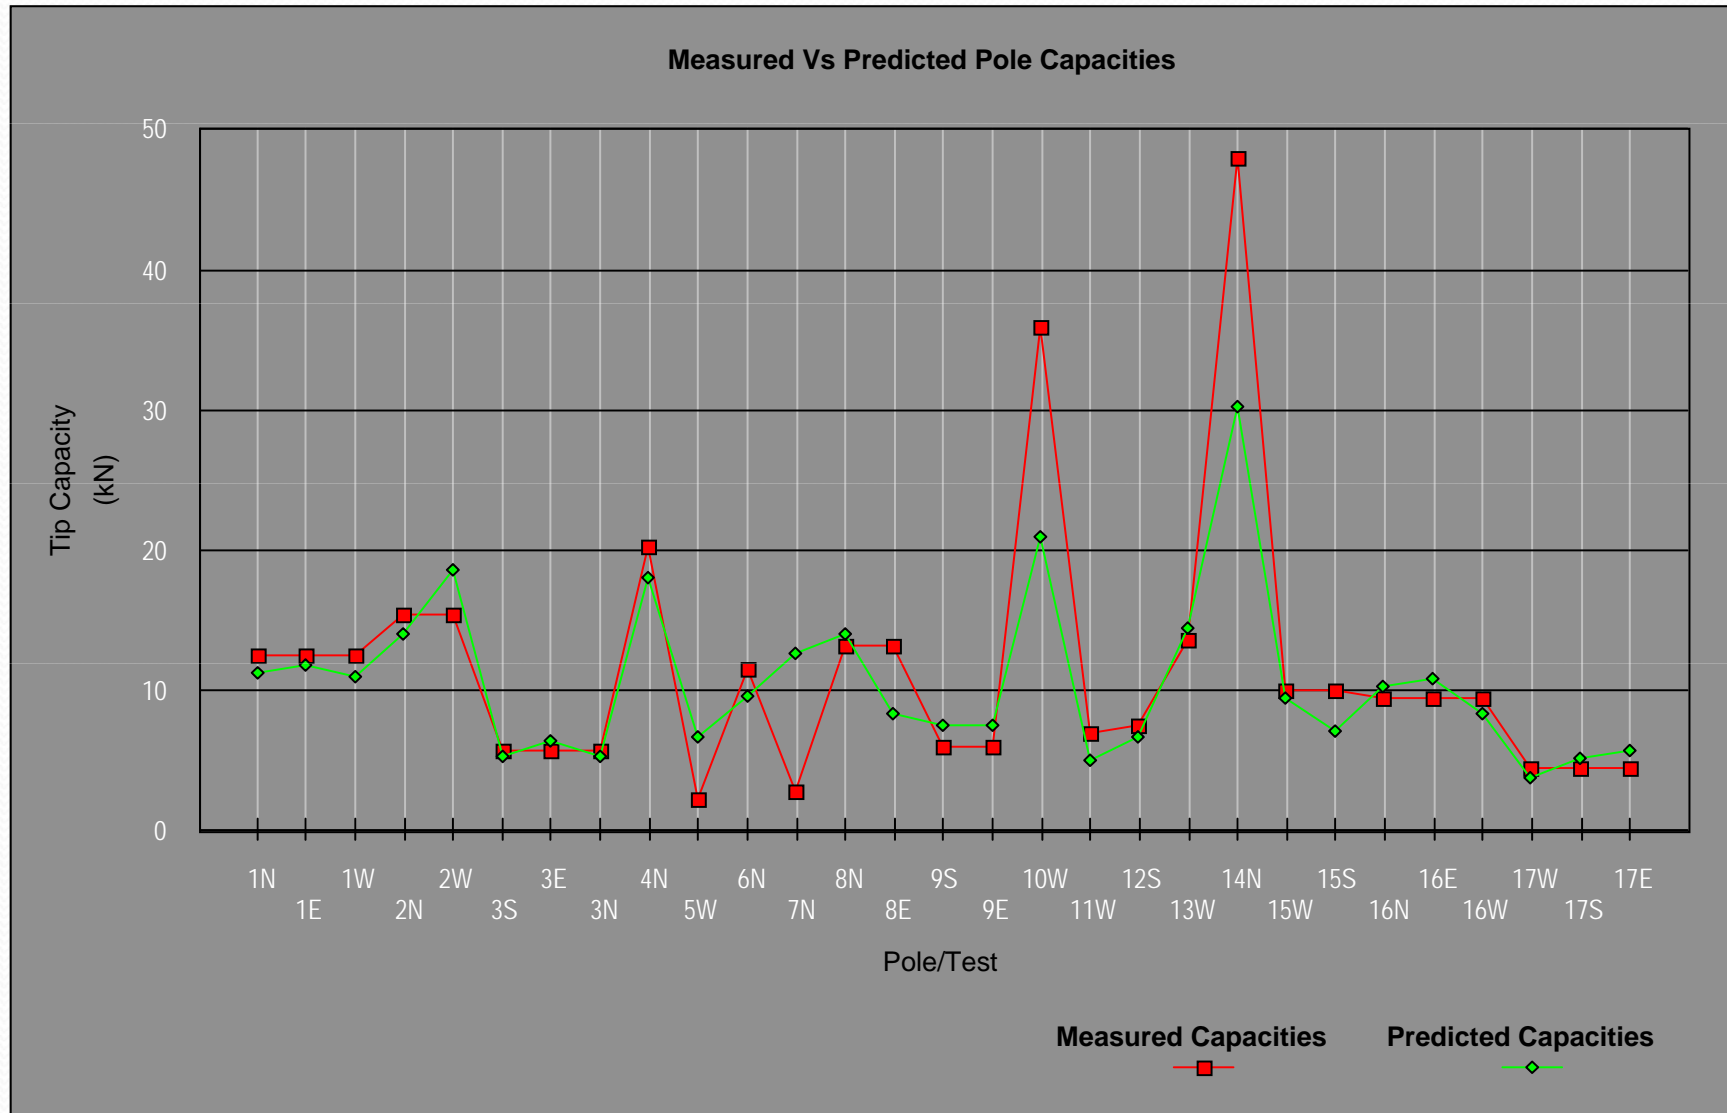
Pole Capacities Predictions

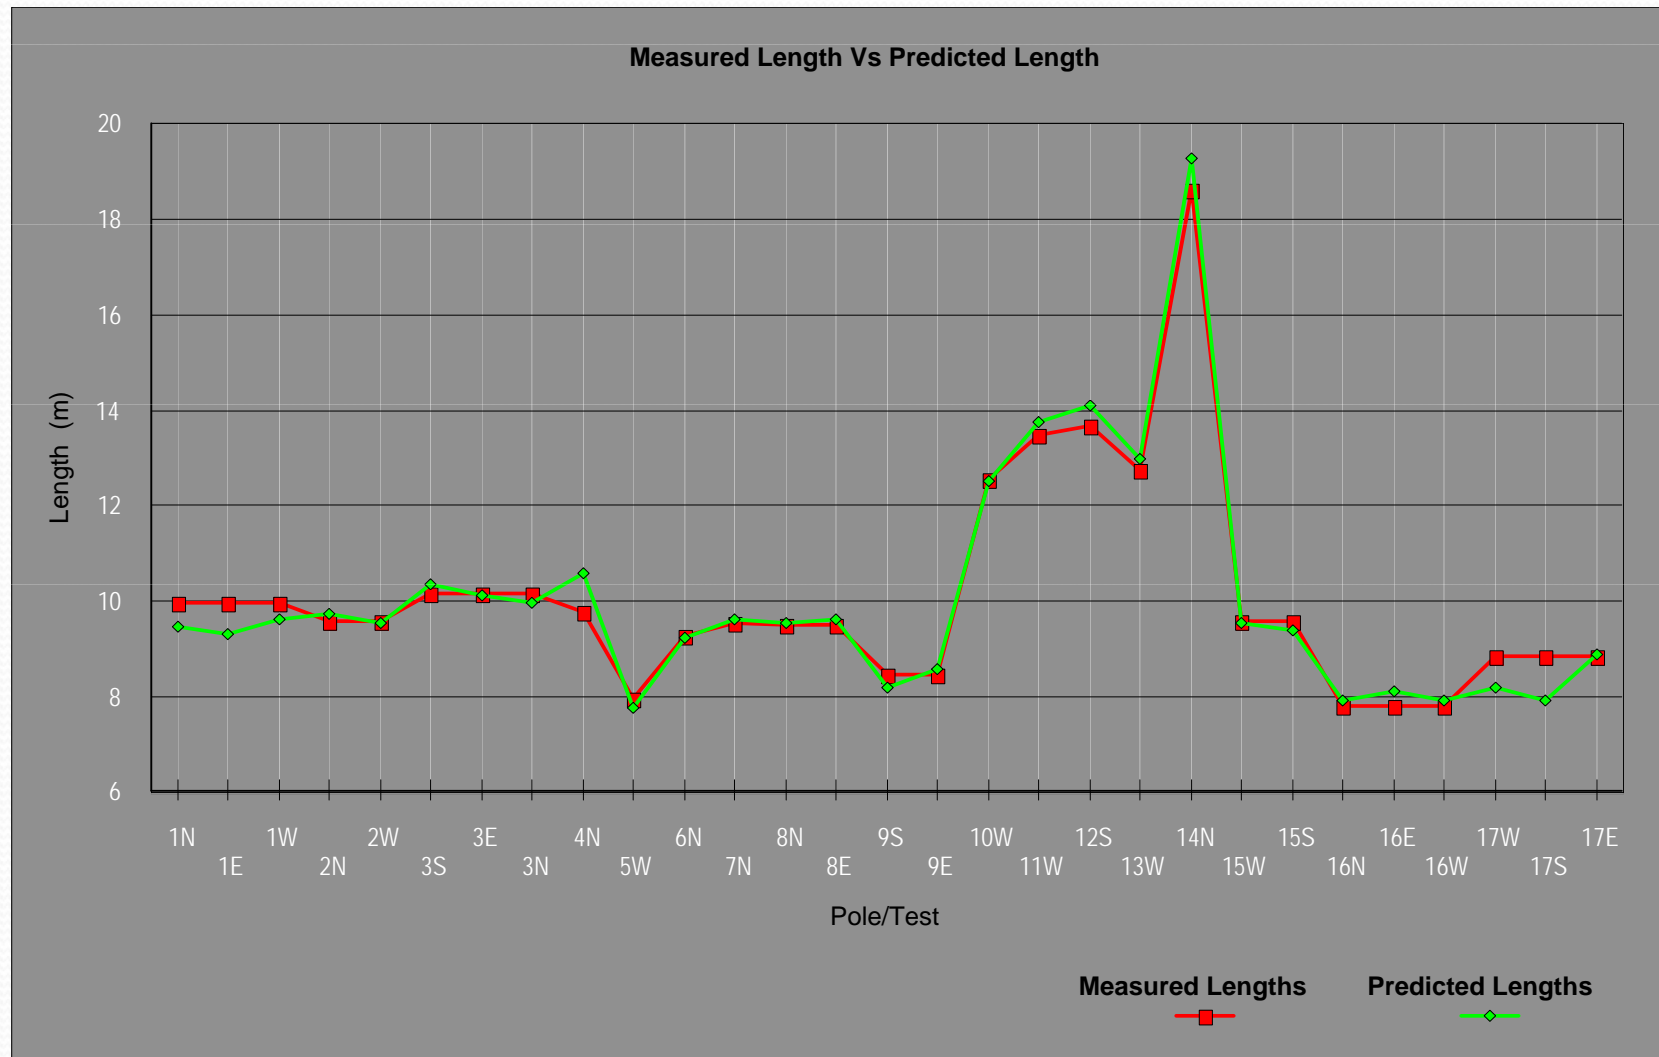
Length measurement and Deflect detection

Determination of unknown burry depth
